# FY2020 CENTRAL TEXAS TURNPIKE SYSTEM ANNUAL INSPECTION REPORT

The condition of the CTTS continues to be maintained in good repair, working order and condition, achieving an overall score of 88 (out of 100). This is a weighted rating that combines the four components of the CTTS: SL1, SH 45N, SH 130 (Segments 1 through 4), and SH 45SE. The results of this year's inspection are indicative of the age of the project and the proactive manner in which the project is maintained.

## ANNUAL INSPECTION REPORT FOR THE FISCAL YEAR ENDING AUGUST 31, 2020

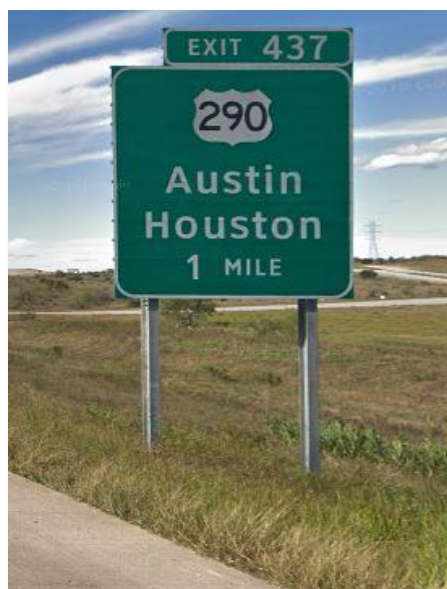
**Figure 5: Large Guide Sign on SH 130**

A traffic operations & safety appurtenance score rating of 84.0 was achieved across all roadways in the system, compared to 88.2 last year. The decrease in score was primarily due to degraded delineators, particularly on SH 130, which received a score of 73.4. In addition, the lowest traffic operations & safety appurtenances element score was small signs, which received a score of 72.7 and was noted on SH 45SE.

In addition, a complete large guide sign inventory was performed, and both daytime and nighttime assessments were conducted. The findings for this year's inspection indicated that 13.6% of the large signs received a rating of 3 or below, with 2.9% receiving a 1 or 2 rating. The remainder of the signs received a 4 or 5 rating, which is considered Good to Excellent. The signs receiving ratings of 3 or below consisted of various deficiencies, such as degraded retro reflectivity, loose, separated, or bent panels, punctures, warping, peeling, and signs being hit and fallen to the ground.

The current roadway PBMC requires the maintenance contractor to address all traffic operations & safety appurtenances deficiencies that are considered routine. Routine deficiencies include response times which are stipulated and addressed as part of the PBMC scope. In addition, with the large guide signs approaching the end of the typical service life, TxDOT is scheduled to let a

systemwide large sign replacement project in the Spring of 2020, which will address many of the sign deficiencies that were identified during this year's inspections.

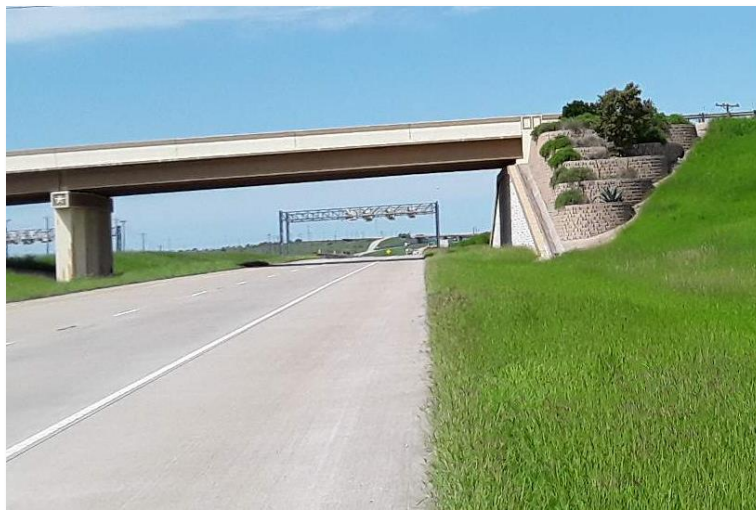
**Figure 6: Roadside Conditions**

The determination of the roadside score for roadside features is generally based upon the consideration of vegetation management, litter removal, drainage structures, and other elements located outside of the paved travel way (Figure 6). The roadside category achieved an overall score of 93.0, compared to 94.1 last year. The decrease in score was primarily due to increased litter, particularly on SH 45SE, which received a score of 69.3.

The current roadway PBMC requires the maintenance contractor to address roadside deficiencies that are considered routine. Routine deficiencies include response times which are stipulated and addressed as part of the PBMC scope. In addition, it is anticipated that the pavement upgrade projects, as well as the SH 130 expansion projects mentioned in Section 2.2.1 will be addressing some of the roadside deficiencies that were found.

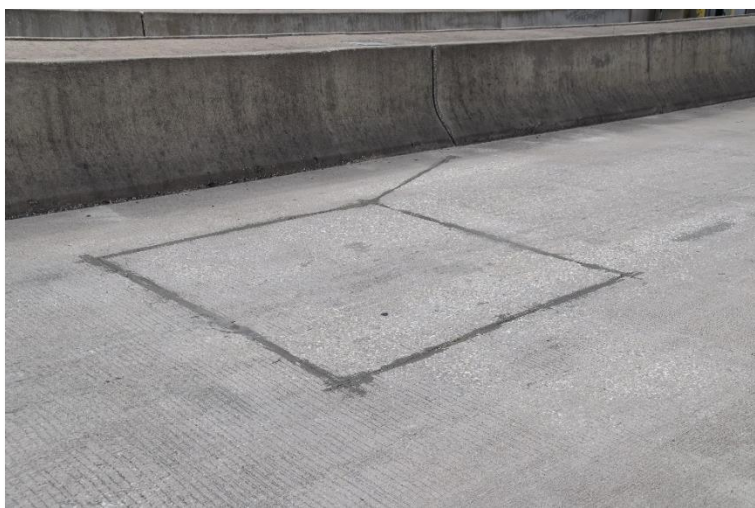
**Figure 7: Toll System Pavement Showing IVIS**

In 2015, as a result of numerous loop sensor failures on CTTS facilities, per TOD request, Atkins conducted a study to investigate the potential causes of the failures. These in-pavement loop sensors, shown in Figure 7, are called IVIS that detect and classify vehicles traveling through the toll zone. The study found that multiple issues could be attributed to the failures, including: damage to the loop sensor wire, improper loop sensor installation, and pavement cracking in the vicinity of the sensors. While pavement cracks were found to be one of the potential causes, the study did not show a direct relationship between the presence of pavement cracks and loop sensor failures. Furthermore, a life cycle cost analysis determined that it is more economical for TOD to continue to replace loop sensors that fail until such time when the toll zone pavement requires complete replacement. TxDOT continuously monitors these locations and performs supplementary inspections and maintenance to ensure that the toll system's collection capabilities are not affected. In FY 2017 two locations were replaced, in FY 2018 four locations were replaced and in FY 2019 four locations were replaced.

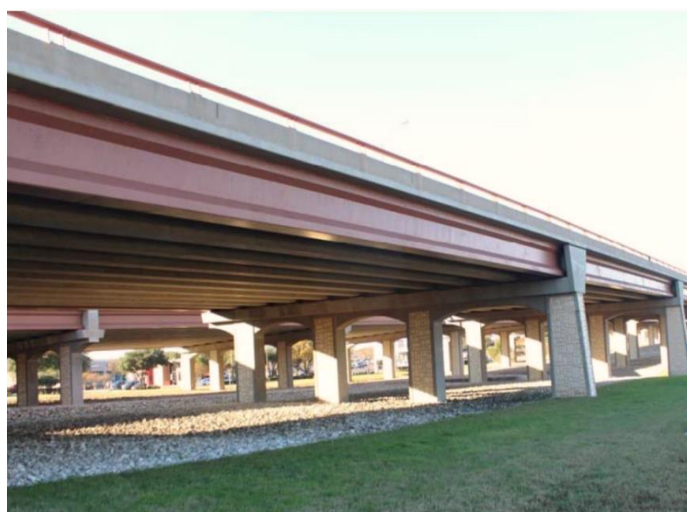
**Figure 11: SH 45N Bridge at Greenlawn Blvd**

TxDOT inspects all bridges within the CTTS biennially, with findings from the most recent inspection (FY 2020) indicating that 90.6% of the components were rated Good to Excellent. A total of 749 components in the categories used to evaluate bridge load ratings were inspected on the 238 structures within the CTTS. Only 70 components (9.4%) had a rating as low as 6 (Satisfactory), with the remainder of the ratings all in the 7 to 9 range (Good to Excellent). The components that received a six (6) rating involved issues such as clogged/disconnected deck

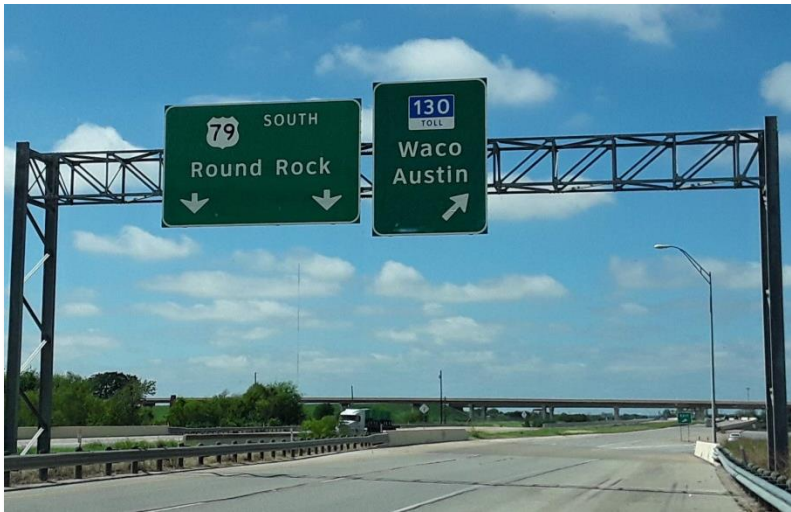
**Figure 12: Overhead Sign Structure**

Starting in FY 2011, inspections for overhead and cantilever sign structures were conducted biennially, with SH 130 and SL1 inspections conducted in one year, and SH 45N and SH 45SE conducted in the alternate year. During this year's inspection, the overhead and cantilever sign structures on SH 130 and SL1 were inspected, which is a total of 115 structures.

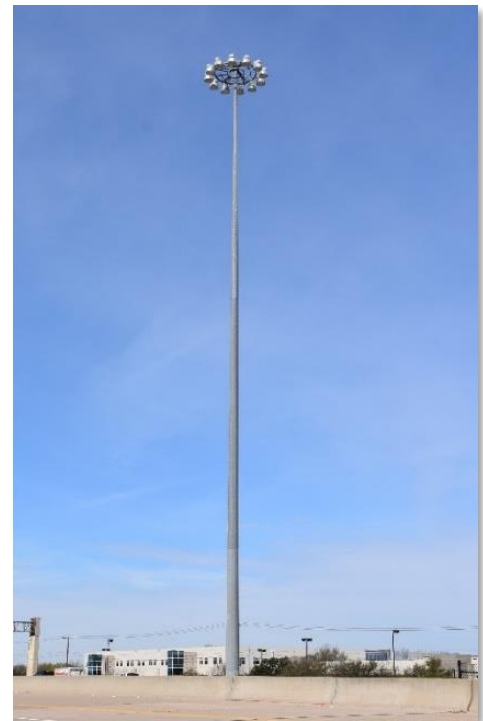
**Figure 13: High-Mast Light Tower**

Beginning in FY 2011, the HMLTs inspection occurred biennially with inspections being alternated on two roadways per year. During this year's inspection, SH 130 and SL1 were inspected, which consists of 29 structures. The results indicate that 99.7% of the 6,351 components were rated Satisfactory to Good and is a 0.1% decline from the SH 130 and SL1 inspection that was conducted in FY 2018.
